**TO ALL FLEET VESSELS**

**Ref: DMA-SAPID/DMADGM/00/C1163**

## ***Oil leakage can end up to engine room fire***

*The following Loss Prevention circular describes an incident of oil leakage from cylinder head cover.*

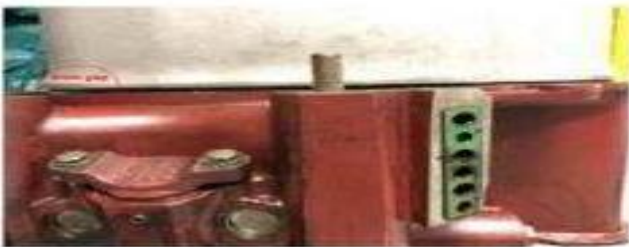
*However, the cover of cylinder number one was not mounted correctly and the guide pin of the cover was not in the recess of the cylinder head on the exhaust side (see image top left).*

1. Investigation into the source of the leaked oil led to the discovery of the wrongly mounted cover.
2. Quick action by losing the cover and giving it a gentle tap to make it fall back in its correct position, stopped the oil leakage.

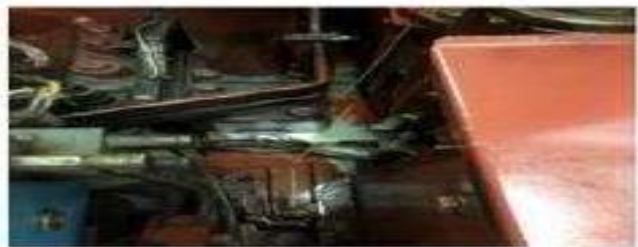
The gap was not noticed because the vessel had a slight list to starboard so the leaked oil was flowing from the cylinder head on the block in between the turbo charger and the regulator into the fuel oil leak tray (see image top right). Only after the vessel made a turn to portside, did the duty engineer notice the oil leak (see image bottom right).

3. The remaining spilled oil was quickly removed from the cylinder head and block.
4. The oil underneath the exhaust gas line was already starting to vaporize so quick removal of this oil was essential to prevent a possible fire.
5. After the clean-up, one of the engineers was assigned as a fire watch to check the exhaust gas line and engine.
6. The potential consequences of the oil leakage could have been an engine room fire.
7. The possible leakages from pressurized pipe can lead to accumulation of flammable gases & very high risk of fire.
8. The practice of standard & general husbandry and workmanship on board the ship & especially in the Engine Room can be an effective prevention method for all types of garbage being accumulated as well as quick response to any leakage from various tanks & liquid holding reservoirs/ receptacles.

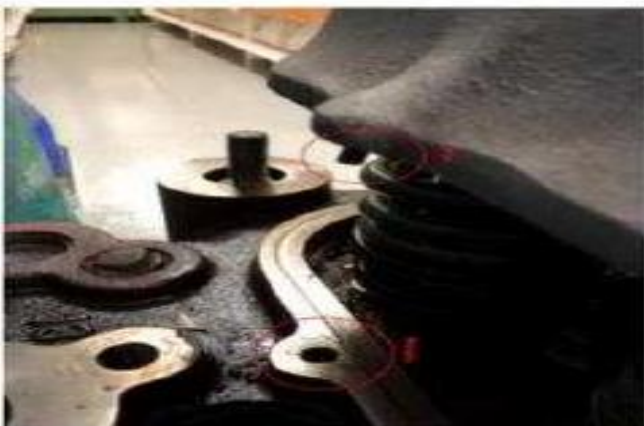
*The misaligned mounted cover resulted in a small 3mm gap between cover and the sealing surface (see image bottom left). This was not noticed at that time by the crew executing the regular maintenance as the gap is not visible from the walk platform side (cam-side).*
