Subject: DMA/AIFI01 - ALL FLEET VESSEL - DA11 - QITAPI-LP-35-2020(MAIB Extracted Accidents & Lessons to be Learnt).

***Loss Prevention Circular QITAPI-LP-35-2020
(MAIB Extracted Accidents & Lessons to be Learnt)***

The following case studies have been extracted from the UK MAIB Safety Digest 1-2020:

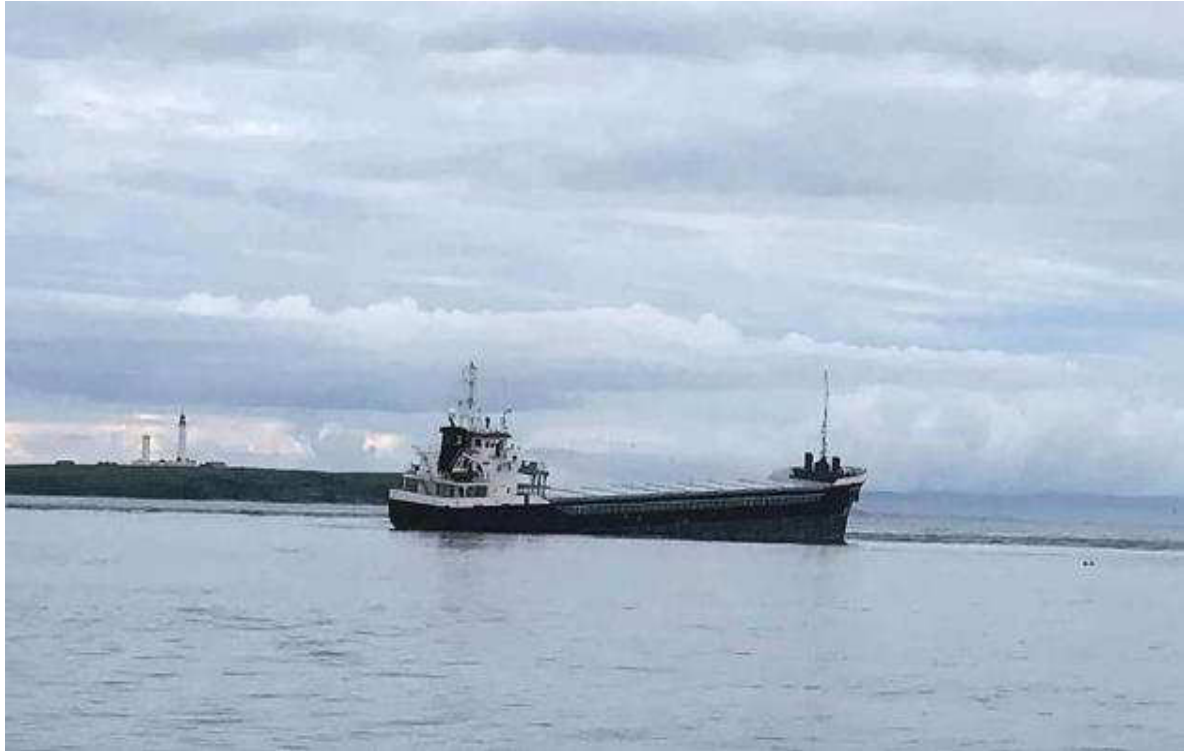
A small cargo vessel was on sea passage and heading towards the coastline of the country of its next port of call. The OOW had taken over at 0200 and soon thereafter had started watching music videos on his mobile phone.

Between about 0230 and 0430 the vessel was slowly set off the planned track by the tidal stream in the area. This resulted in the vessel heading towards some outlying, uninhabited rocky islands, marked by a lighthouse. However, the risk of grounding had not been observed by the OOW.

The vessel was also proceeding towards an area where there was a voluntary reporting zone and a VTS area. Watch-keepers ashore noticed that the vessel was heading into danger, and made verbal warnings. However, the OOW did not respond in sufficient time to prevent grounding heavily on rocks.

The vessel was badly damaged by the accident and remained aground for several days until the cargo had been removed and sufficient tugs were available to haul it off the rocks.

The cargo vessel aground with the lighthouse visible in the background

1. The accident happened primarily because the OOW was distracted from navigation by the use of a mobile phone. This is a hazard that must be guarded against by appropriate policies for the use of mobile phones at sea.

2. Fatigue was also a potential causal factor. It was the middle of the night and the OOW was alone and bored on a warm bridge. These were conditions that induced a high risk of falling asleep - and he might have done so from time to time.

Combatting boredom and fatigue is about ensuring high levels of supervision and that safeguards, such as the bridge navigation watch alarm (BNWAS), are in use. In this case, the BNWAS was switched off and there were no other alarms in place to warn the OOW of the looming danger.

4. Passage planning is not limited to the intended track on the chart or in the ECDIS. A comprehensive passage plan should identify all the hazards ahead and determine the safest route. This should include identifying all navigation marks, lights and buoys, which should then be positively identified when observed and cross-checked with other navigational data to ensure accuracy of the passage. This vessel was approaching land and the rocky area where it ran aground was marked by a lighthouse, which would have been visual for a long time as the vessel approached. This was vital, visual navigational information that did not feature in the passage plan and was not subsequently utilised for navigational safety on board.

- 1- The use of mobile phones must be prohibited on the bridge, especially during coastal navigation & making a landfall. Using mobile phones for communication would certainly be a hazard & distraction to the person/s on the bridge, if the device is used for other purposes; it can be extremely affecting the situational awareness & lead to accidents.*
- 2- Although the vessel has been of a small size with probably limited crew members on board, but still having a one man bridge while navigating in the proximity of land should be avoided so far as practicable.*
- 3- Such precautions must be included in the Safety Management System & thus audited at appropriate intervals to make sure that such incorrect workmanship is not practiced on board vessel/s of the company.*

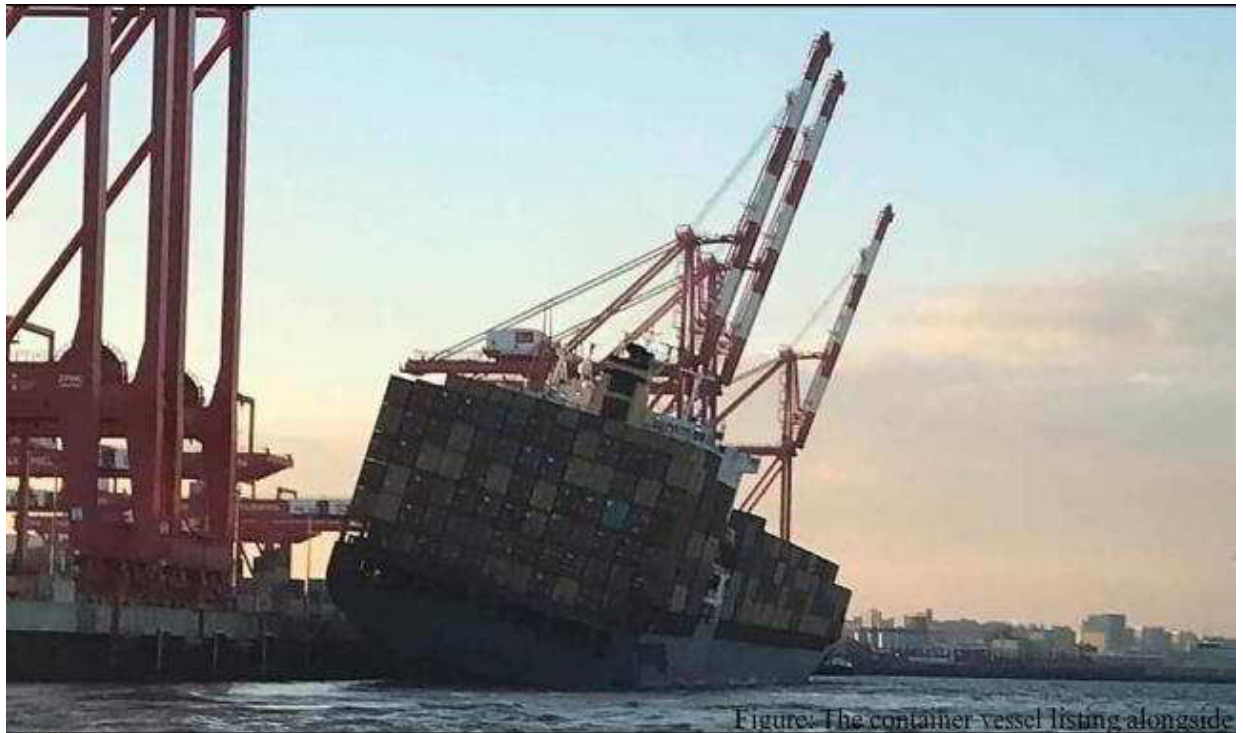
Having completed loading, a container vessel was preparing to sail; the weather was fine with a gentle breeze. The chief officer decided to pump additional water into the starboard ballast tanks to level up tank volumes. This decision was based on his observation of port and starboard ballast tanks' contents from the tank capacity gauges on the operating panel. As the volume of water in the starboard tanks increased, the vessel started to list heavily to starboard. As the situation deteriorated, all the crew evacuated ashore.

After an assessment by the managing company, the master and the port authority, it was deemed safe for the crew to return on board and recover the situation by pumping out the ballast water from the starboard tanks. After the incident, manual soundings were taken, which showed that one of the port ballast tanks' gauges had been reading full when the tank was actually empty, and the fault was almost certainly an airlock in the gauge system.

Figure: The container vessel listing alongside

1. Ballasting operations should be planned, and maintaining an accurate picture of the state of the ballast system is critical for the safety and stability of the vessel.
2. Given the vessel was upright, it should not have made sense to add water to one side. When the vessel started to list, it would have been readily apparent that the ballasting was the problem, and this should have been stopped immediately.
3. Ballast system gauges are prone to inaccurate readings, so tanks should be sounded regularly with the levels recorded in the ballast logbook. This information can then be compared with gauges to check for discrepancies.
