**Ref: DMA-SAPID/AIFI01/99/C1107**

**Date: 2020.05.28**

## Engine Room Fire Safety - Condition survey findings

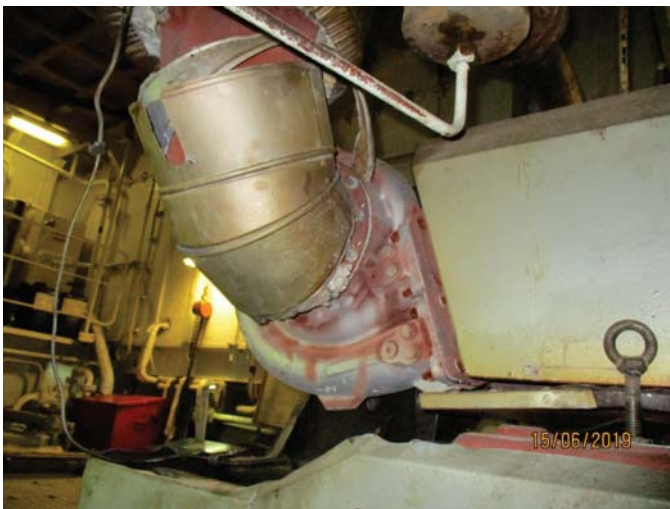
Exhaust gas casing, indicator valve shields and lagging degrade with time due to vibration, repeated heating and cooling down or disassembly and refitting during maintenance. The crew must make sure that high temperature surfaces are adequately protected at all times when there is a risk of flammable oils being sprayed over the surface.

**Damaged and missing insulation of the engine exhaust gas turbocharger and uptakes**

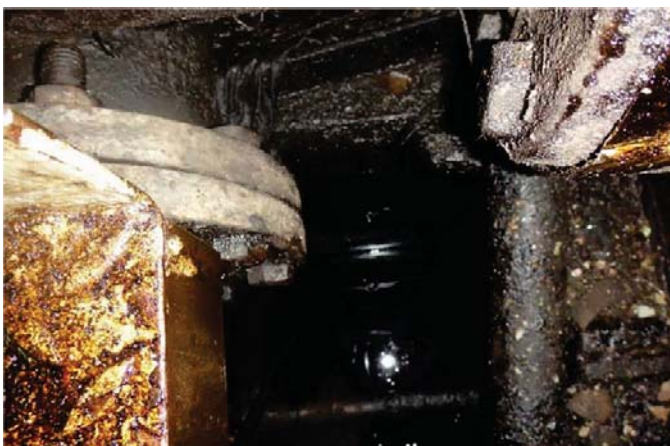
**Oily bilges in the Engine Room**

Dirty bilges, stained engine entablature and makeshift solutions such as leak collectors and plastic hoses may be set on fire by hot work such as welding or grinding. These will also provide an additional source of fuel to sustain and spread an engine room fire. Proper housekeeping along with the timely identification and elimination of oil leaks are of utmost importance for the prevention of fires in engine rooms.

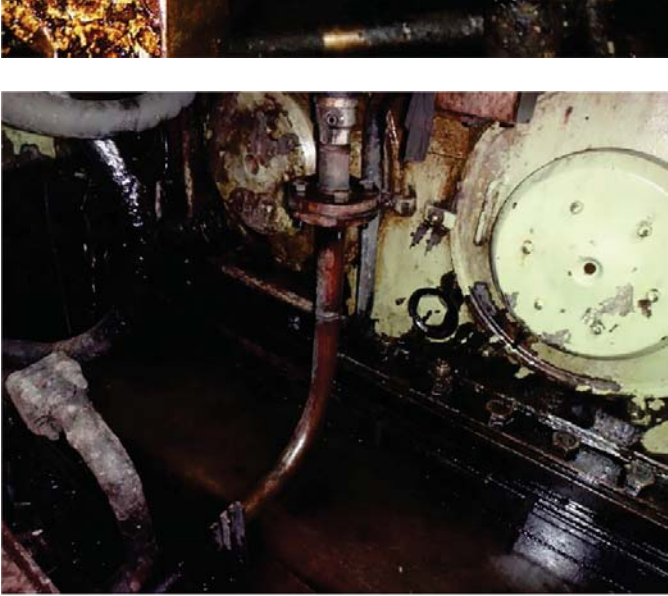
## Oil stained engine entablature

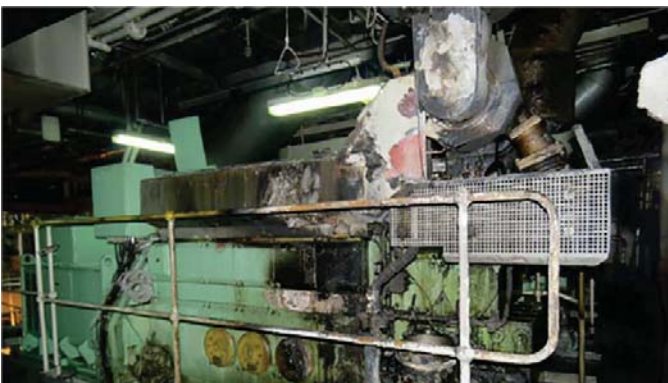
## Consequences of the engine room fire

Consequences of the engine room fire which may have started when the fuel from the damaged filter casing sprayed over the engine exhaust manifold.

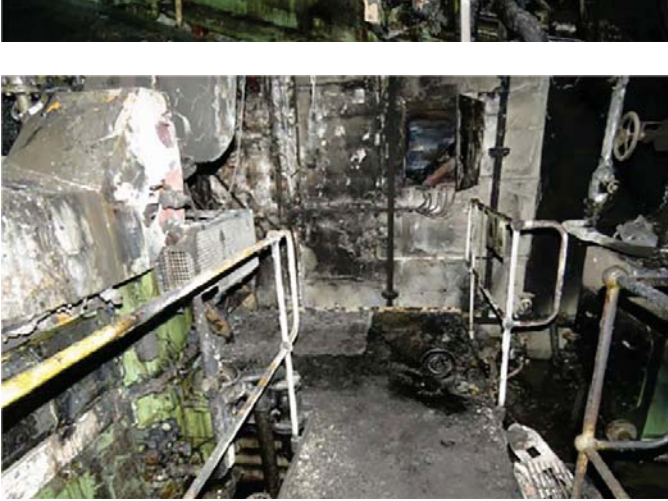
## Consequences of the engine room fire

Consequences of the engine room fire which may have started when the fuel from the damaged filter casing sprayed over the engine exhaust manifold.
