Ref: DMA/AIFI/98/C 1091

Recently one of the fleet bulk carrier vessel, while awaiting to receive bunker at Hong Kong OPL anchorage experienced adverse weather condition and resulted in vessel dragging.

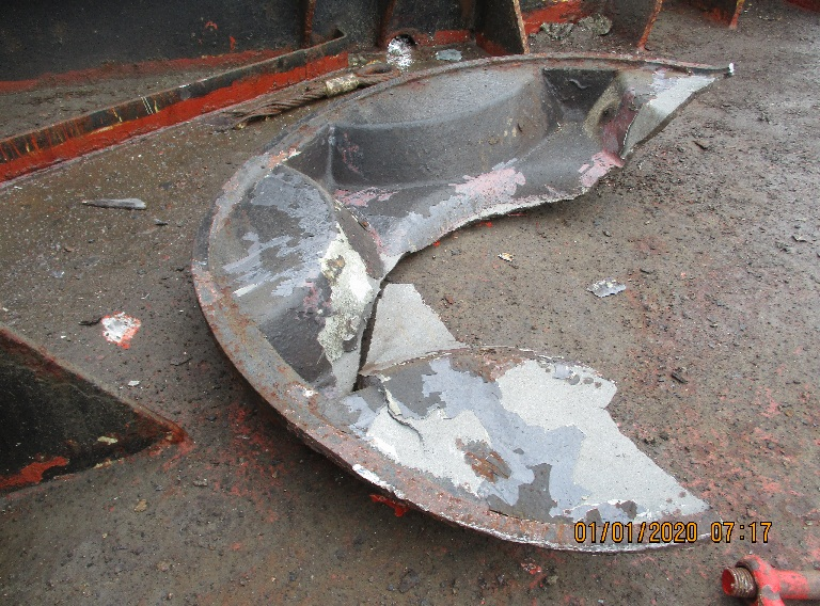
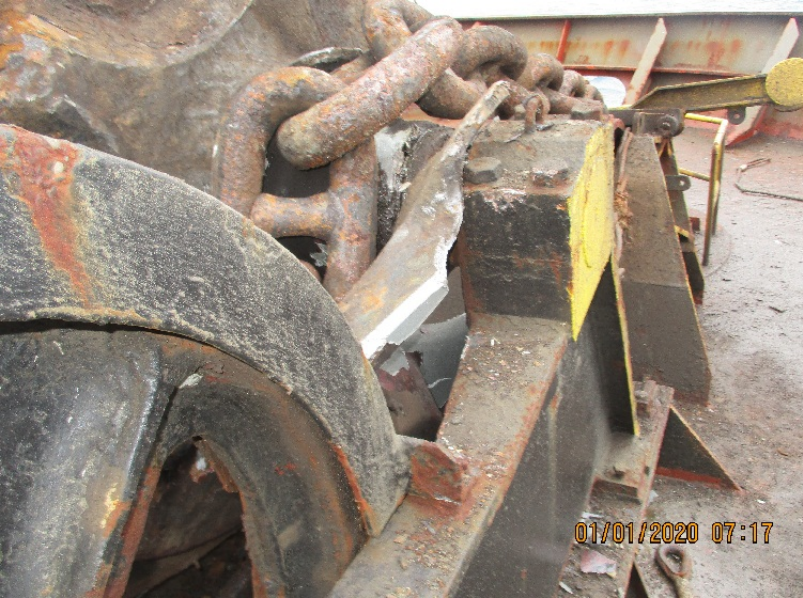
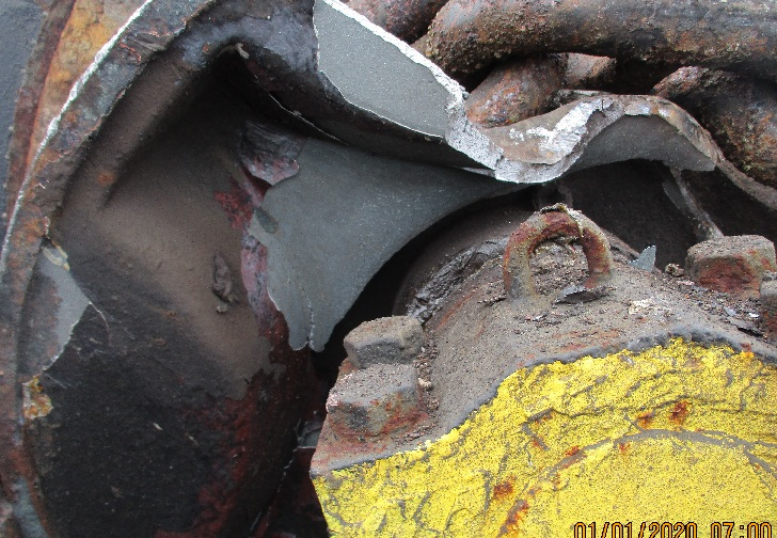
On the next day chief officer reported that Pawl Pin (Stopper Pin) has been dented, then master decided to reduce the weight and tension on the chain to avoid further damage to the pin and stopper. After engine got ready master tried to reduce the tension but due a sudden heavy pitching, vessel sustained severe damage on her anchor windlass due to excessive weight on the chain and windlass which caused Gypsy to break in to pieces.

As the gypsy was parted the anchor could not be retrieved and heaved up by using windlass therefore master had to cut the chain and ultimately vessel resumed her passage with one anchor after receiving bunker.

- Heaving up anchor in strong wind and high seas is extremely challenging.
- Mistake can easily lead to grounding or collision.
- Minimize the tension on the chain and keep the chain as vertical as possible.
- In windy weather conditions or strong current the rudder and engine must be fine-tuned to prevent high tension on the chain and overloading of the windlass motor.
- Close communication between bridge and anchor party on deck is essential.

- Windlass condition shall be carefully checked for any sign of material failure or technical defect before attempting anchor operation.
- Ensure that planned maintenance program has been well maintained for all parts of anchor arrangement.
- Vessel's speed shall be continuously monitored.
