From: aifi02@sealeaders.com
Sent: Tuesday, September 17, 2019 5:31 PM
Cc: dma@sealeaders.com; FLINSPECT; gm1@sealeaders.com; gm2@sealeaders.com; gm3@sealeaders.com; gm4@sealeaders.com; gm5@sealeaders.com; gm6@sealeaders.com; md; s_a_hosseini_343@yahoo.com; shipmanagement3@sealeaders.com; SM1; SM2; SM4; SM5; SM6; Valfajr ; Valfajr (sqd@valfajr.ir)
Subject: [dma] ALL FLEET VESSELS/ DA-11, Fire due to Funnel Sparks and soot
Attachments: dscf1875-qpr-qpr.jpg; dscf1878-qpr-qpr.jpg; dscf1883-qpr-qpr.jpg

Ref : DMA/AIFI/98/C 1055

Date: 17/09/2019

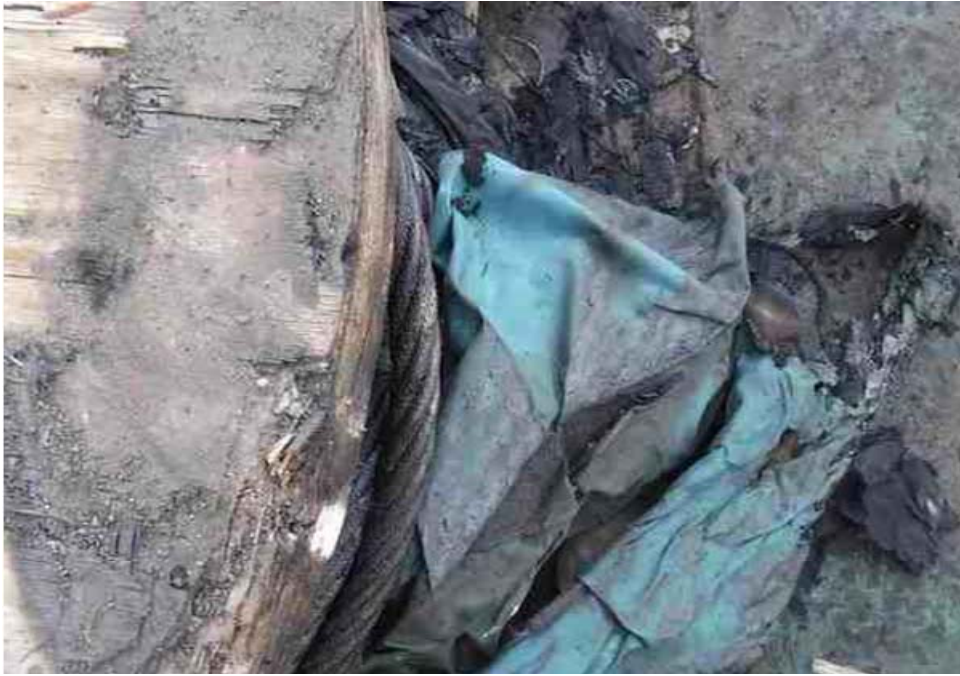
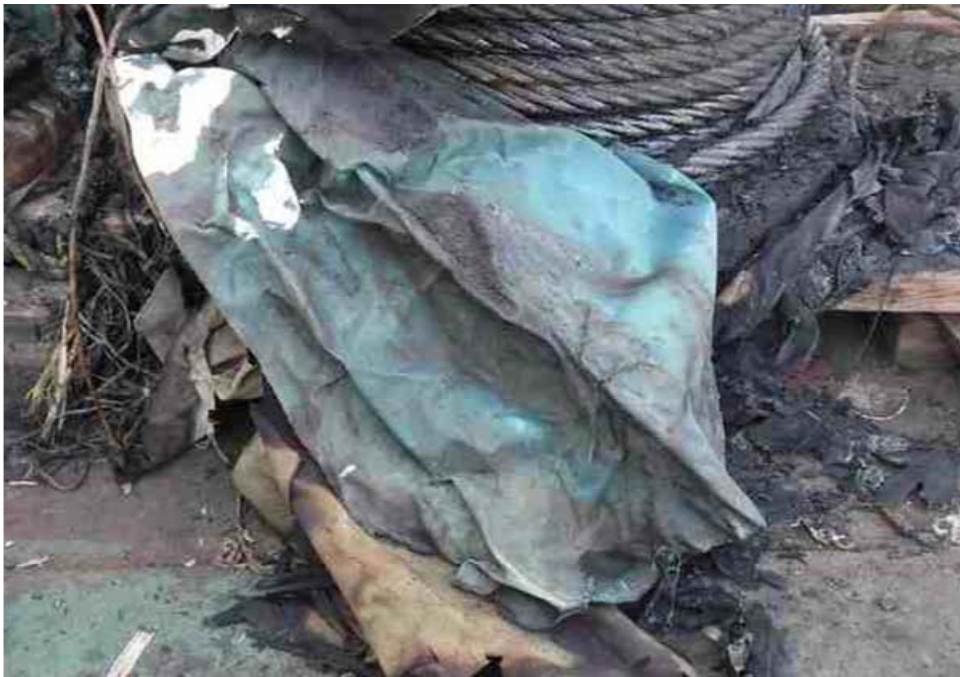
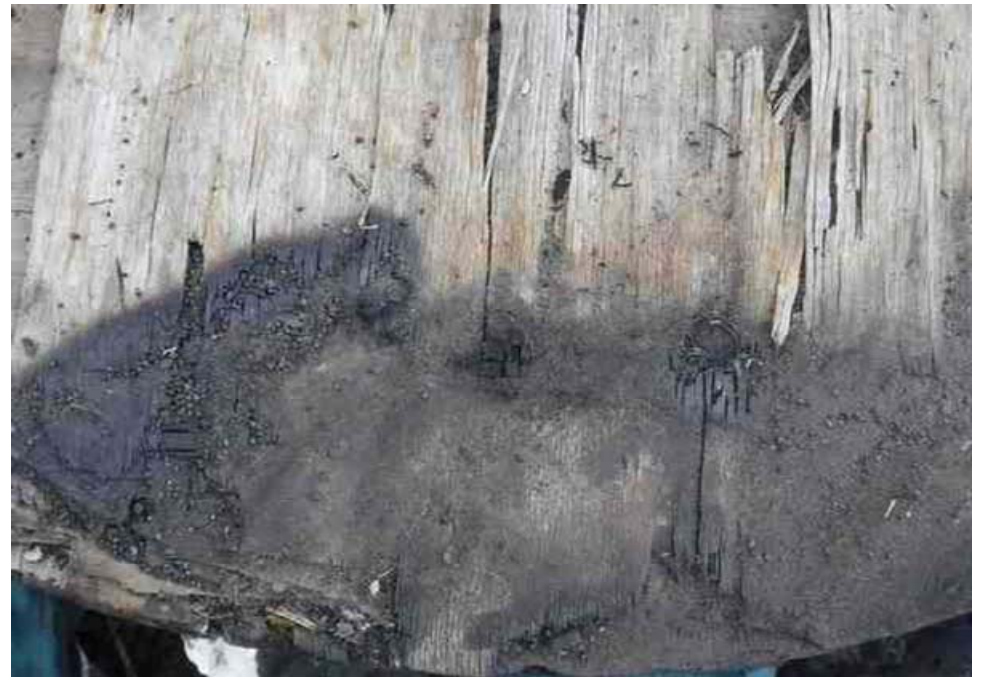
According to Master's report, while pilot was dis-embarking from vessel, second officer reported abnormal amount of sparks and soot coming out of funnel. Engine room was notified and fire patrol was carried out immediately on poop deck and surrounding area and no fire was detected. After about 45 minutes, smoke was sensed by ship's staff inside accommodation and fire search was carried out again during which it was found that plastic sheet covering spare crane wire and its wooden reel had been partly burnt (Attached snap shots) . Fire was extinguished satisfactory.

During time, thick carbon had been deposited inside the boiler smoke tubes and funnel uptake. By passing of hot exhaust gases, these carbon deposits were pushed out of funnel in form of sparks. These sparks had then fallen down on poop deck and in contact with combustible materials of spare crane reel had caused the fire.

1. Avoid spark emission by maintenance and cleaning procedures (Soot Blowing);

- a) It is recommended to soot blow the boiler tubes prior to arrival and after departure from a port. Boiler tubes should be soot blown as per its maker's instruction manual.
- b) At sea, the Master/officer on bridge watch should be consulted prior to commencing the soot blowing operation and the vessel's course altered if necessary.
- c) A boiler that has been running for a longtime is sure to have soot deposits on its tubes, hence Chief Engineer has arrange washing of the boiler exhaust pipes at regular intervals and carry out the blow of the boiler tubes by means of the soot blow arrangement.
- d) As a precaution against funnel fires and sparks, burners, tubes, uptakes, exhaust manifold and sparks arresters (if fitted) should be maintained in good working condition.

2. If there is a funnel fire or sparks emitted from the funnel, in addition to immediate rectify the matter;

- a) (By All Vessel) Continuous firefighting patrol with appropriate firefighting equipment to be established on areas where the sparks falling, such as accommodation decks, aft poop deck , etc. to tackle every source of fire.
- b) (Especially by Tanker Vessels), if at sea, consider altering course as soon as possible to avoid sparks falling on the tank deck. Any cargo ballasting or tank cleaning operations in progress must be stopped and all tank openings closed.
