Ref : DMA/AIFI/96/C 845

Lessons Learnt: Flooding of cargo hold

Vessel Type: Container

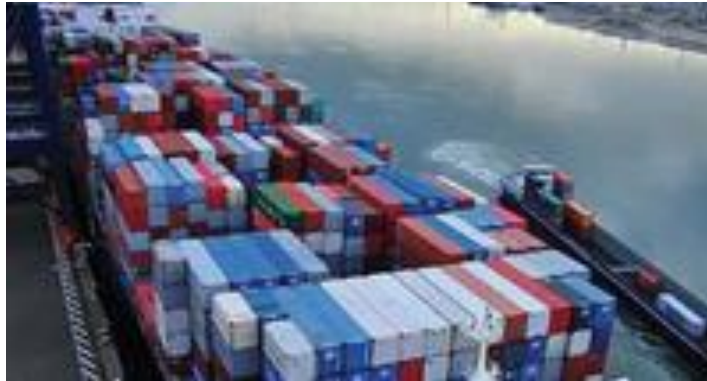
During cargo operations, the duty deck officer noticed the presence of a large quantity of water within one of the holds. He immediately informed the master and arrangements were made to transfer the water into a holding tank using the hold bilge pumping system. The depth of water was measured to be almost 6 metres and approximately 30 containers were fully or partially submerged. When the hold was pumped dry, the affected containers were discharged and jointly inspected at the Receivers premises where significant damage to the cargo was found due to sea water ingress through the container seals and vents. Investigation on board revealed that the flooding of the hold was caused by water ingress through corrosion fractures in the tank tops of two deep ballast tanks located at the port and starboard sides of the space.

It was reported that the ballast tanks in way of the holds were routinely not filled to capacity as a precautionary measure. However, on this particular voyage, the subject tanks were filled to 100% capacity allowing water to leak through the defective tank top plating. Due to the nature of container ship operations, it may be difficult for the crew to closely inspect and hydrostatically test hold boundaries on a frequent basis. However, every opportunity should be taken to do this as operations allow so that any

deficiencies are reported and rectified to maintain the watertight integrity of the holds. Cargo hold tank top base fittings are also vulnerable to fracture when containers are landed heavily during loading. In this case the hold bilge high level alarms, which may have provided early warning of flooding, were also found to be out of order.

- Inspection and hydrostatic testing of cargo hold boundaries with ballast tanks should be incorporated into the vessel planned maintenance system
- The precautionary partial filling of tanks is not a substitute for the proper maintenance of tank tops and the resulting free surface may adversely affect stability
- Cargo hold bilges should be sounded on a daily basis as weather permits and high level alarms, if fitted, regularly tested to maintain function
- Containers are not designed for immersion in water and flooding incidents of this nature can result in very high value claims
