Ref : DMA/AIFI/96/C 850

Lessons Learnt: Contact with Jetty

Vessel Type: Tanker

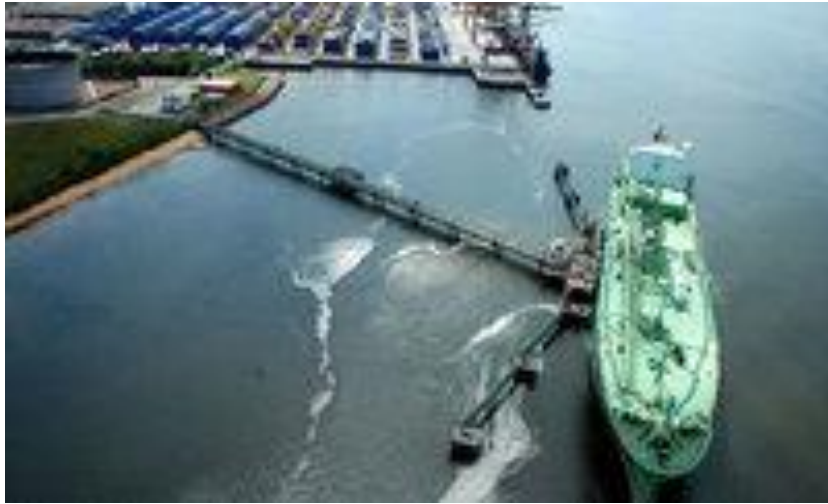
This partly laden tanker was proceeding inbound along a river channel to berth at a jetty for cargo discharge. The transit was being made in daylight in good weather conditions on a flood tide. In addition to the pilot, the master was supported by the second officer with an AB on the helm. In order to berth stemming the tide, it was agreed that the vessel would swing in a turning basin close offshore from the jetty. As the vessel commenced turning to port into the basin, the pilot requested speed reductions from Half Ahead to Dead Slow Astern within the space of 2.5 minutes. At this point the master moved to the port side bridge wing to check upon the position of a tug approaching from astern to make fast. In his absence, the pilot requested Half Ahead on the telegraph to which the second officer complied despite the vessel still making 5 knots headway and closing on the jetty. Upon returning to the wheelhouse, the master noticed the situation and immediately placed the telegraph at full astern and ordered both anchors to be let go. Despite these actions, the vessel's bow contacted the jetty, resulting in significant damage to both ship and shore structures.

The reported circumstances of this incident suggest a lack of control being exercised in the navigation of the vessel in a number of important aspects.

It is evident that the speed of the vessel on approach to the berth was not being properly monitored or regulated so as to arrive at the turning basin with sufficient space and time in hand to perform the manoeuvre safely. Not only was the speed excessive but tugs were not made fast prior to commencing the turn as intended. When the pilot ordered a clearly incorrect engine movement during the turn, this should have been challenged by the second officer notwithstanding the master being absent from the wheelhouse at a critical time. Ultimately the bridge resource management exercised between the officers and pilot was inadequate in that the passage plan, including transit speed and execution of the turning manoeuvre should have been discussed and agreed upon at the outset and any departure from the plan promptly addressed.

- The planned passage to or from a berth are to be fully appraised and agreed upon at the master pilot exchange stage
- During pilotage passages the vessel speed should be carefully monitored and progressively reduced in good time prior to anticipated manoeuvres
- Good bridge resource management requires that the pilot and bridge team clearly communicate their intentions and promptly challenge any departure from the passage plan or if otherwise in doubt as to the safety of an order
