Ref : DMA/AIFI/96/C 862

Engine Room Fire Burns for 12 Hours

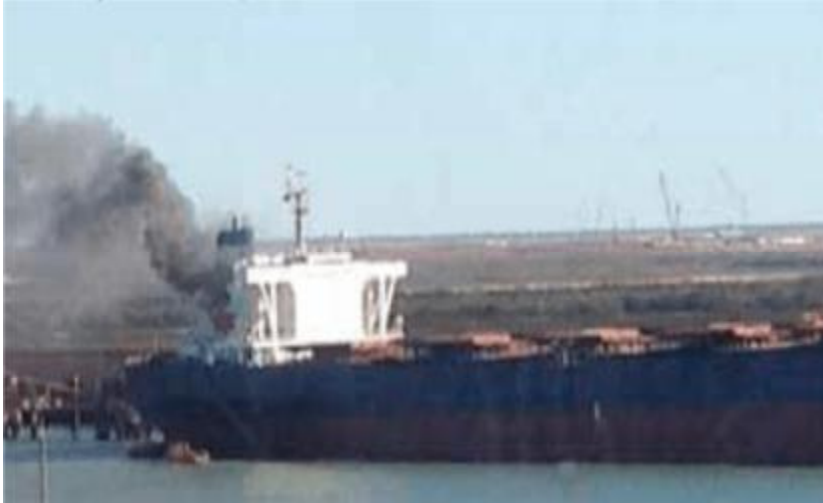
A bulk carrier was being loaded when the ship's fire detection system activated. Soon after, fire alarms began sounding throughout the ship and many (though not all) of the accommodation fire doors closed automatically. The chief engineer, who was in the engine control room (ECR), went to investigate and saw smoke and flames coming from the generator fiat. He made an unsuccessful attempt to extinguish the fire using a portable fire extinguisher, then returned to the ECR and phoned the bridge, confirming there was a fire in the engine room. Shore-side assistance was called. By this time, thick black smoke was building up quickly in the accommodation area.

It was later discovered that the CO2 gas was not fully released due to multiple failings linked to maintenance and testing of this equipment. Because the engine room was not effectively sealed the fire continued for about 12 hours until it burnt itself out. The fire was caused by fuel oil spraying from a generator on to a hot surface. A fuel oil pressure gauge compression fitting on the generator had failed due to a less than adequate repair.

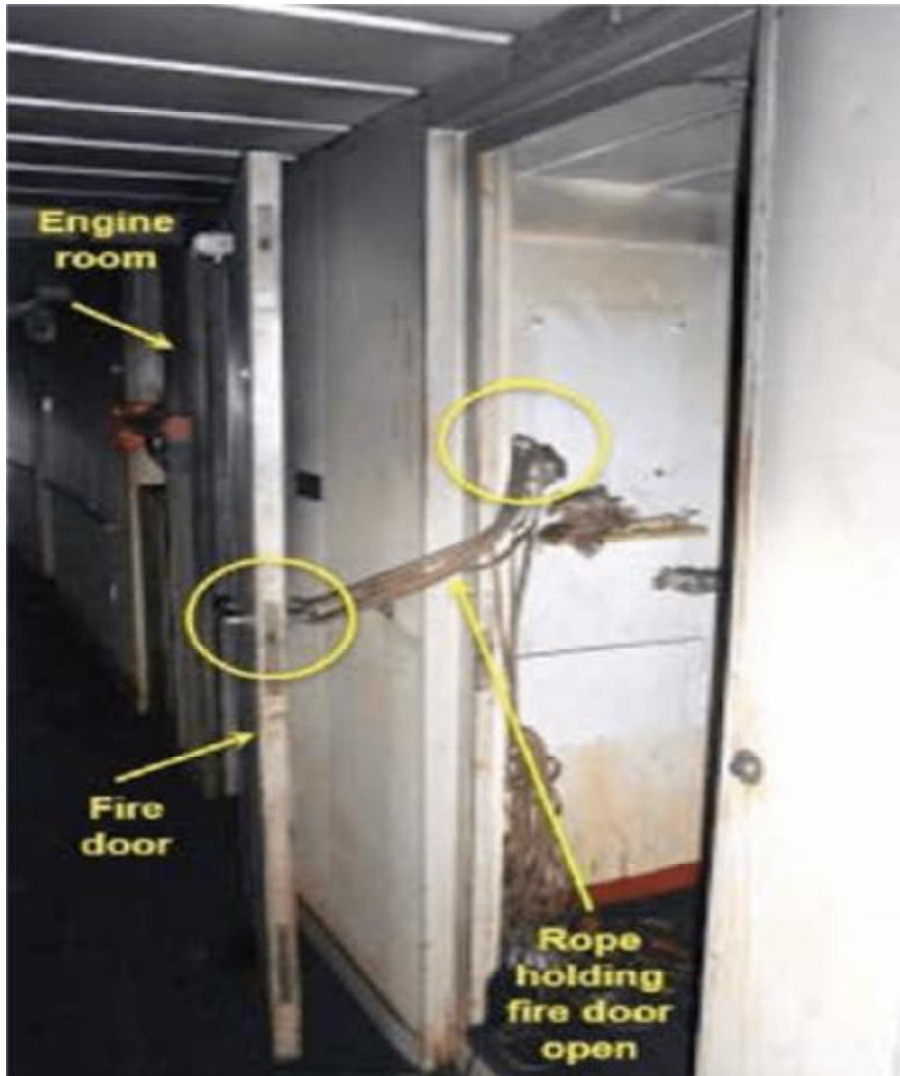
- A number of the vessel's engine room fire doors were held open by wire and/or rope. The open doors allowed the smoke to spread across the engine room and into the accommodation spaces.

- The maintenance of the opening and dosing arrangements for the vessel's engine room fire dampers, ventilators, and other openings was inadequate. Several of them could not be closed, making it impossible to seal the engine room to contain and suppress the fire.

- The CO2 gas fixed fire suppression system for the engine room was not fully operational. The multiple failures of the system at the time of the fire were not consistent with proper maintenance and testing.

- The fixed fire suppression system is an essential safety element of your vessel, therefore it shall be ensured that it is properly tested and maintained
- All dampers, openings and mushroom ventilators shall be checked on regular basis to ensure their proper status
- Fire doors shall not be kept open using ropes
- Emergency drills shall be held regularly and the relevant procedures shall be explained/exercised in full detail
