Ref : DMA/AIFI/96/C 878

Date: 13/03/2018

A container vessel was down-bound at about 16 knots in a confined river waterway. A helmsman was executing helm orders in Full Follow Up (FFU) mode and the OOW was on the bridge assisting the two pilots, one of whom had the con. Soon after a course change, once the vessel was steadied up, the vessel's head began to veer to starboard. The pilot with the con mentioned this to the other pilot. The helmsman then said 'Not working,' which was understood by the pilots to indicate a steering failure.

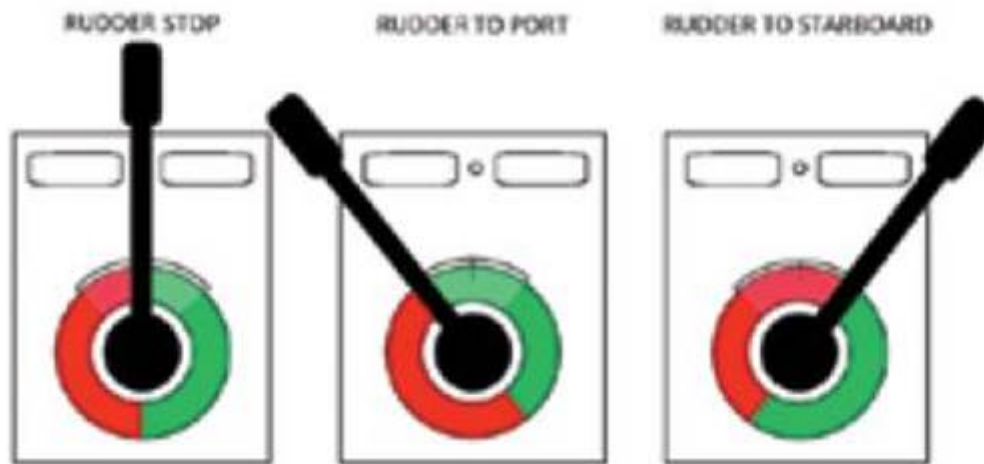
The pilot then activated the handle of the override tiller, placing it hard-a-starboard, but under the impression it was hard-a-port. He did not know that the tiller was installed such that when moved to the right, the red part of the indicating disc would illuminate, even though the rudder went to starboard (see diagram below). The pilot then ordered 'Hard to port' and that the main engine should be stopped. The Master was soon on the bridge, while the chief engineer, who had just arrived in the engine control room, observed that the rudder angle indicator was at 35° to starboard (hard-a-starboard).

The helm tiller was not installed in accordance with the manufacturer's specifications, nor was it consistent with internationally accepted standards. Because the pilot was unfamiliar with the particular ergonomics of the installation he unintentionally put the rudder hard-a-starboard instead of hard-a-port.

- Navigating in a restricted waterway and losing steering, or even assuming you have lost steering, can be stressful and cloud your judgement. As a first reaction, switch quickly to NFU and watch the rudder angle indicator, as well as the ship's heading, for rudder functionality.
- While actual steering gear failures do happen and result in groundings, others have occurred due to an inopportune reaction to an assumed failure, as in this case. For some other examples,
