Ref : DMA/AIFI/97/C 887

Date: 03/04/2018

please find the following TWO LESSONS TO BE LEARNT regarding “fall into the water and fall from the crane over the hatch cover” :

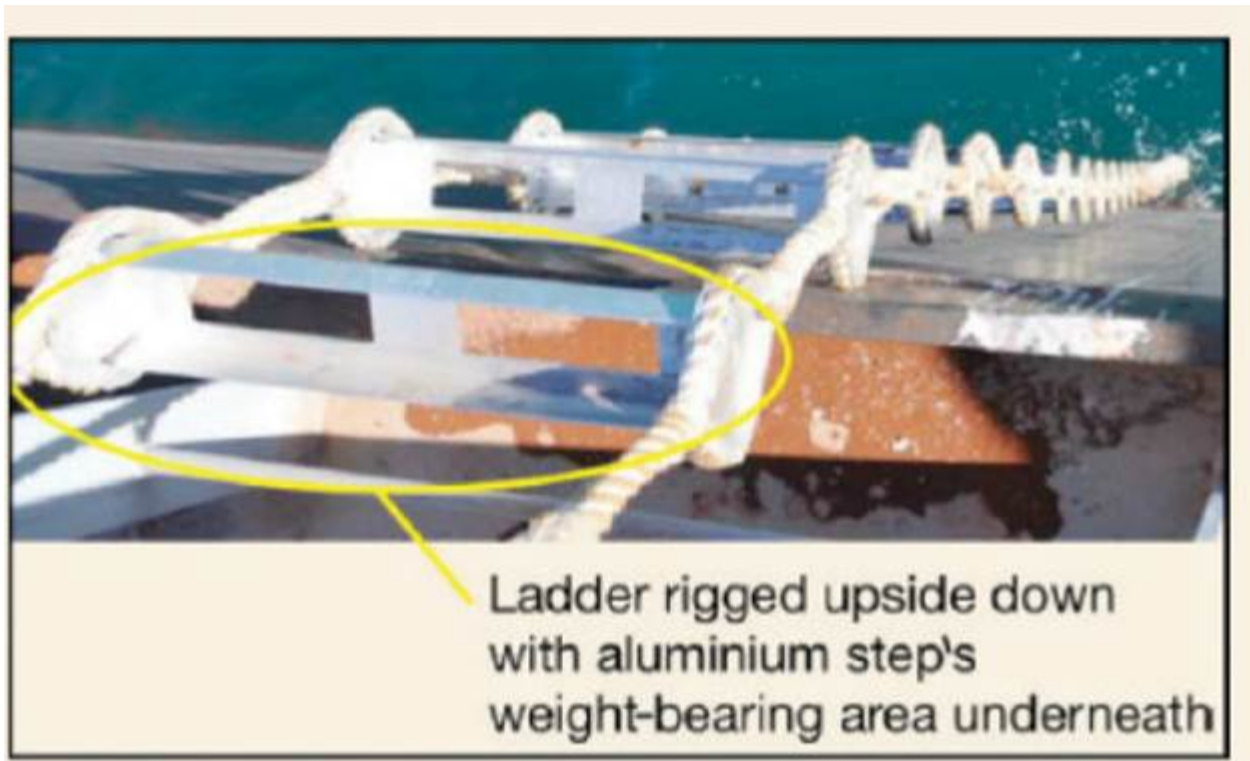
Case 1: Seven-meter fall into the water

An investigation later found that the victim had gone over the side without fall protection on a ladder that was installed upside down.

- In many cases, little attention is paid to planning apparently straightforward tasks, such as using a rope ladder. This can lead to important considerations not being taken into account, including the experience and physical ability of persons undertaking the task, not to mention the actual installation of the ladder.

- A 7-metre descent (presumably then followed by an ascent) on a rope ladder is a feat that should be attempted only by those who are physically fit.
- A good rule of thumb is that fall protection should be used in cases where a crew member is at risk of falling 2.4 metres or more.
- In this case, the lifejacket worn was well intentioned but had little effect, because sea conditions were not safe.

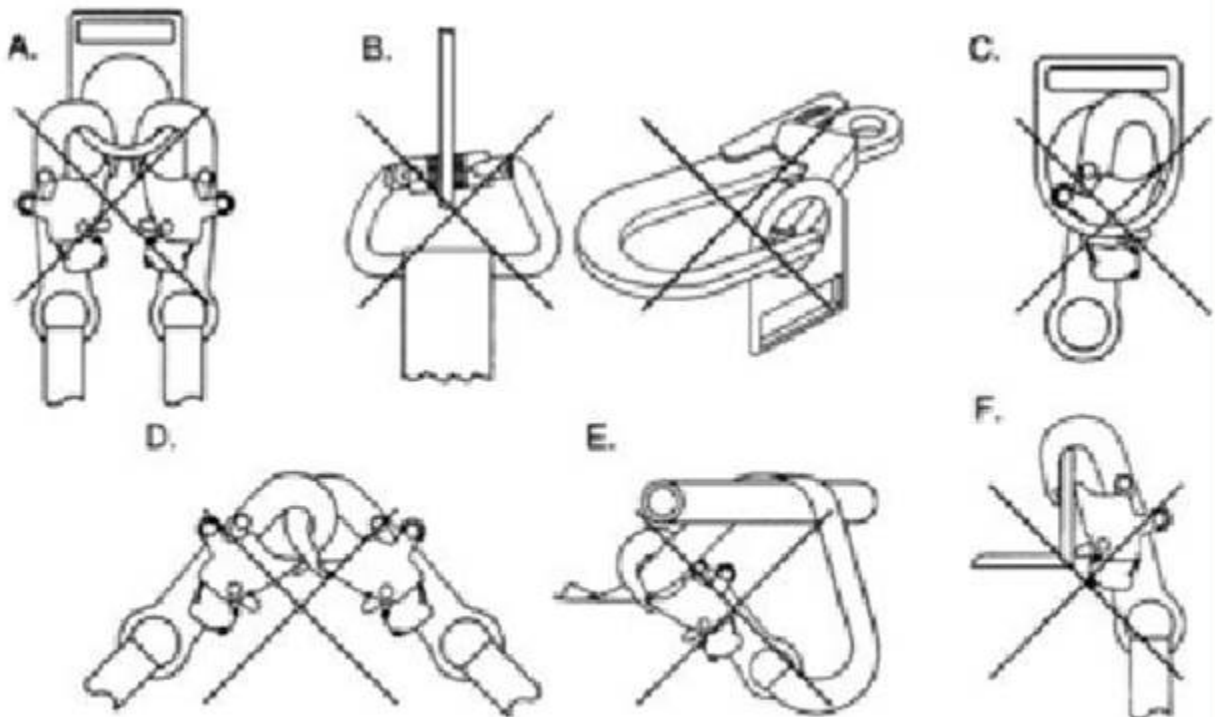
Examples of IMPROPER connections

- A. Do not attach two or more snap hooks or carabiners to a single D-ring.
- B. Do not load a carabiner or snap hook at the gate.
- C. Ensure that connections are compatible and secure.
- D. Do not attach two snap hooks or carabiners together.
- E. Do not tie back on a lanyard unless specifically designed to do so by the manufacturer.
- F. Ensure that the snap hook is closed and locked.
