Ref : DMA/AIFI/98/C 1042
Date: 10/08/2019

Engine Room Fire Safety - Condition survey findings

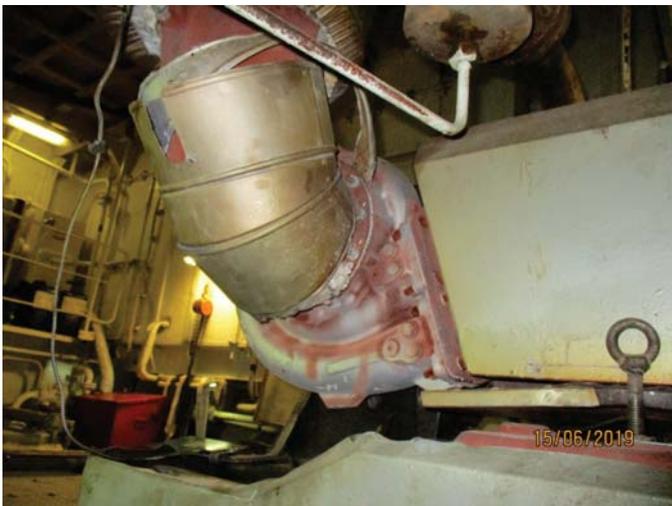
Damaged and missing insulation of the engine exhaust gas turbocharger and uptakes

Exhaust gas casing, indicator valve shields and lagging degrade with time due to vibration, repeated heating and cooling down or disassembly and refitting during maintenance. The crew must make sure that high temperature surfaces are adequately protected at all times when there is a risk of flammable oils being sprayed over the surface.

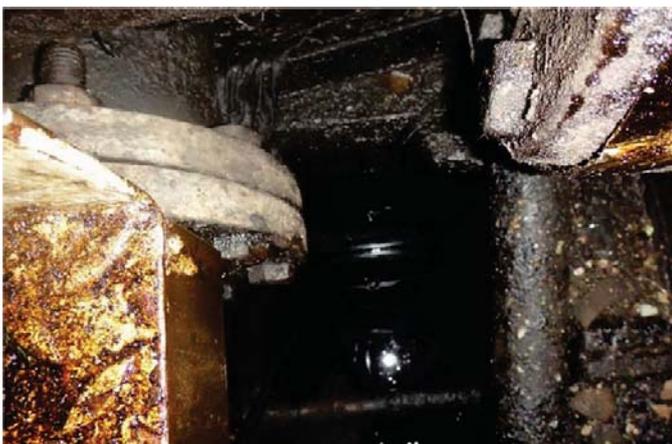
Oily bilges in the Engine Room

Dirty bilges, stained engine entablature and makeshift solutions such as leak collectors and plastic hoses may be set on fire by hot work such as welding or grinding. These will also provide an additional source of fuel to sustain and spread an engine room fire. Proper housekeeping along with the timely identification and elimination of oil leaks are of utmost importance for the prevention of fires in engine rooms.

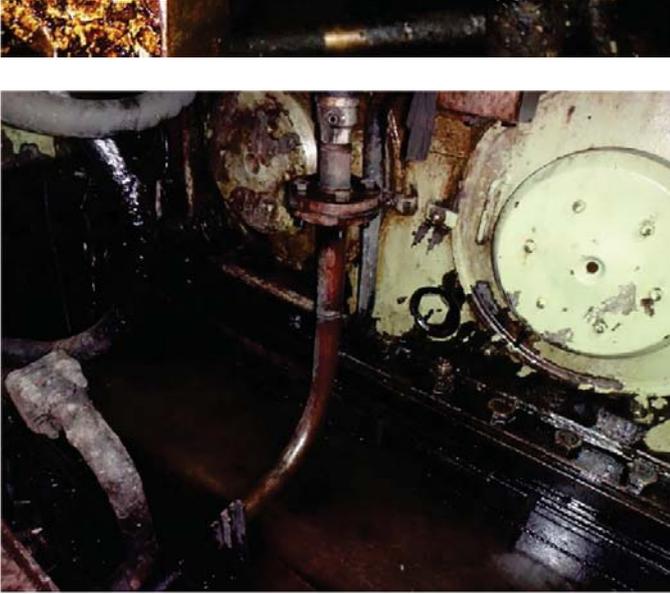
Oil stained engine entablature

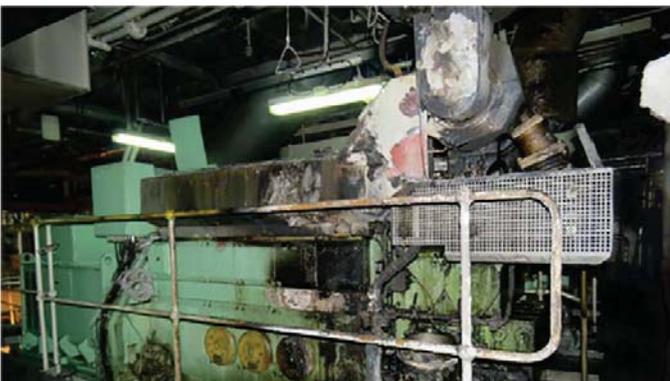
Consequences of the engine room fire which may have started when the fuel from the damaged filter casing sprayed over the engine exhaust manifold.

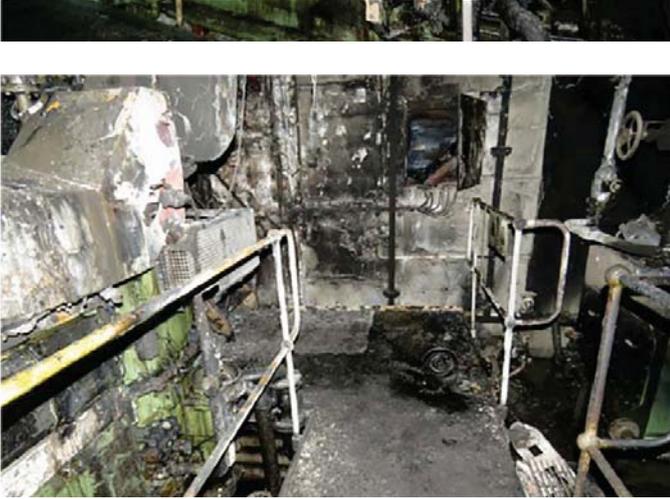
Consequences of the engine room fire which may have started when the fuel from the damaged filter casing sprayed over the engine exhaust manifold.
