**Ref: DMA-SAPID/AIFI01/99/C1107**

**Date: 2020.05.28**

## Engine Room Fire Safety - Condition survey findings

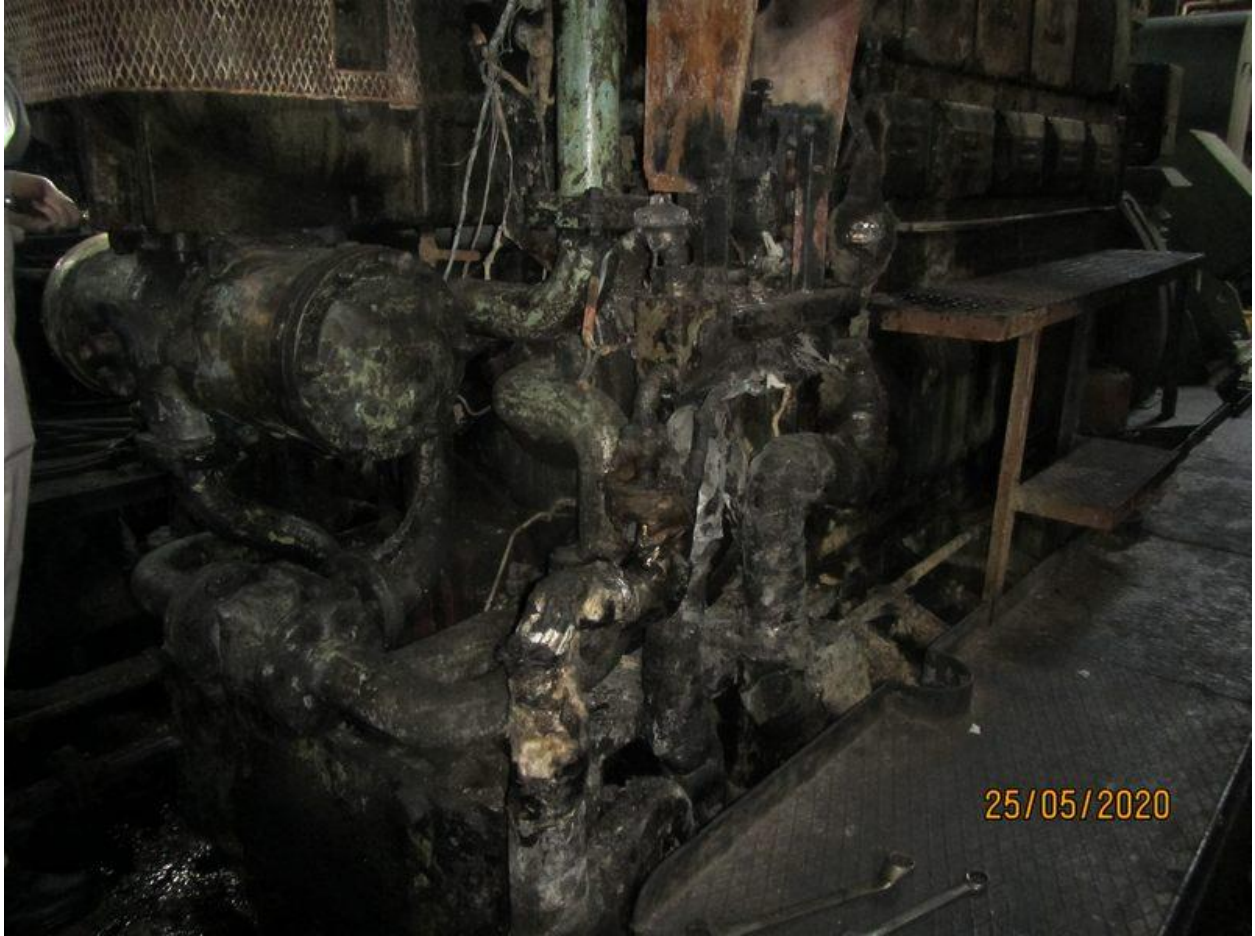
**Damaged and missing insulation of the engine exhaust gas turbocharger and uptakes**

Exhaust gas casing, indicator valve shields and lagging degrade with time due to vibration, repeated heating and cooling down or disassembly and refitting during maintenance. The crew must make sure that high temperature surfaces are adequately protected at all times when there is a risk of flammable oils being sprayed over the surface.

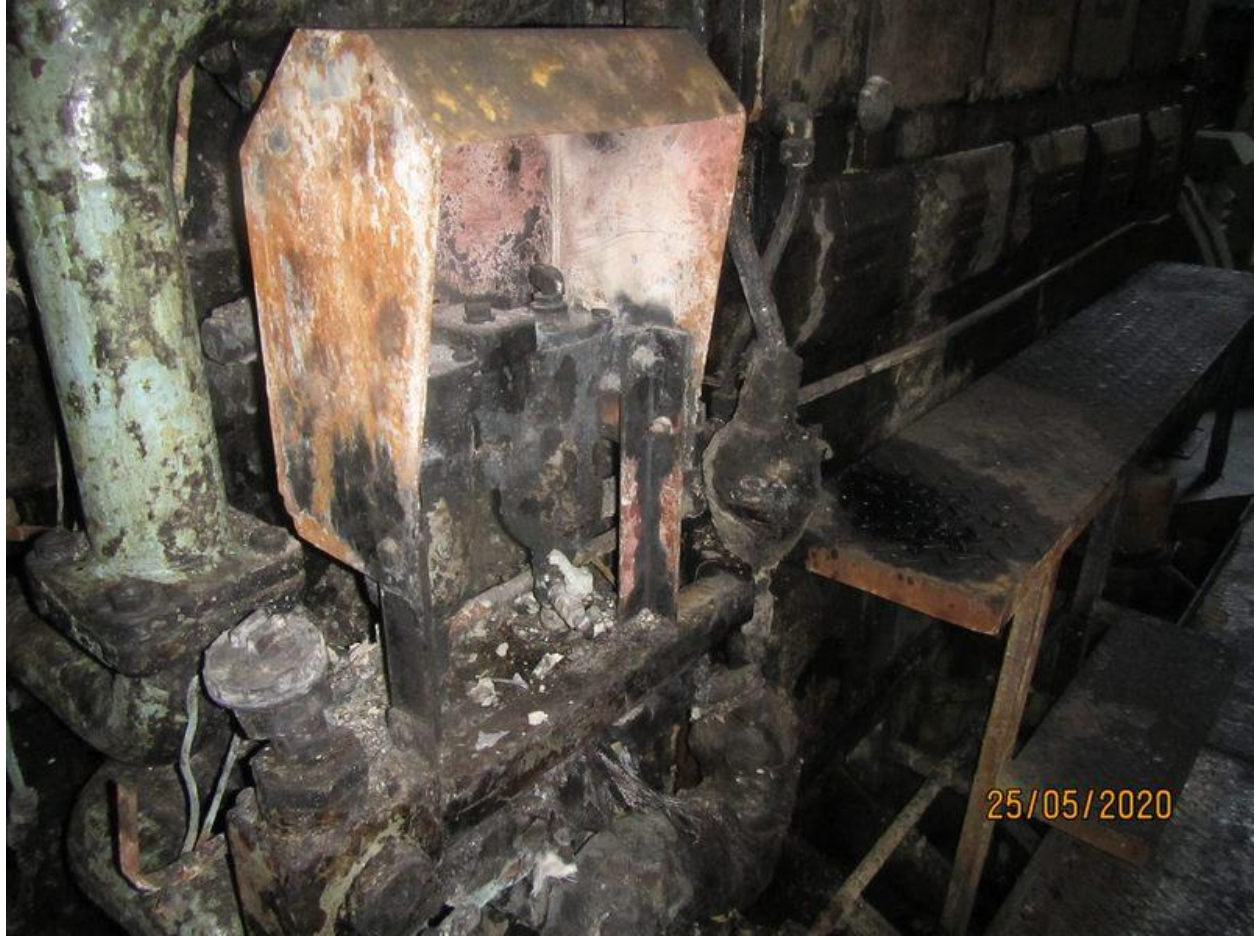
## Oil stained engine entablature

Dirty bilges, stained engine entablature and makeshift solutions such as leak collectors and plastic hoses may be set on fire by hot work such as welding or grinding. These will also provide an additional source of fuel to sustain and spread an engine room fire. Proper housekeeping along with the timely identification and elimination of oil leaks are of utmost importance for the prevention of fires in engine rooms.

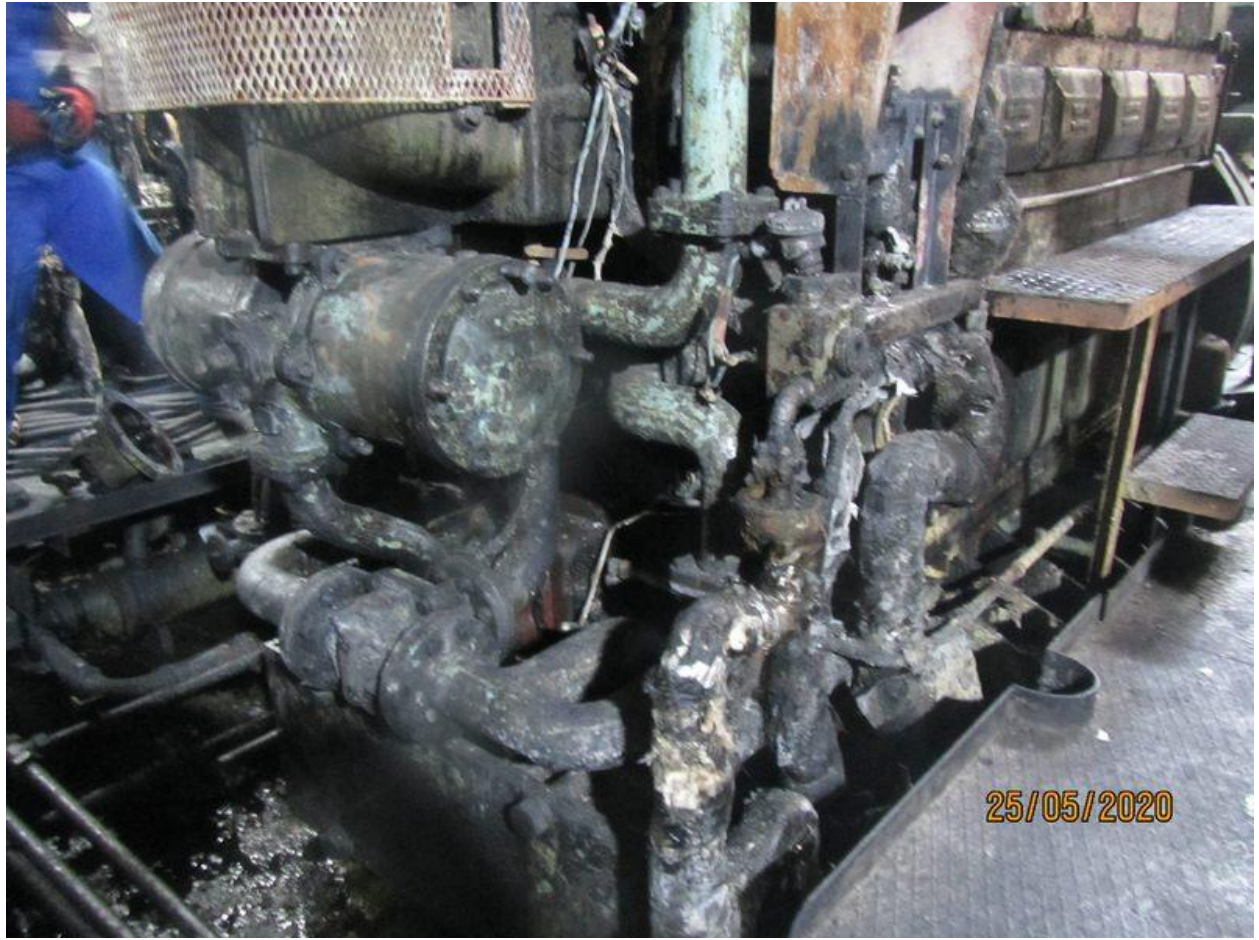
Consequences of the engine room fire which may have started when the fuel from the damaged filter casing sprayed over the engine exhaust manifold.

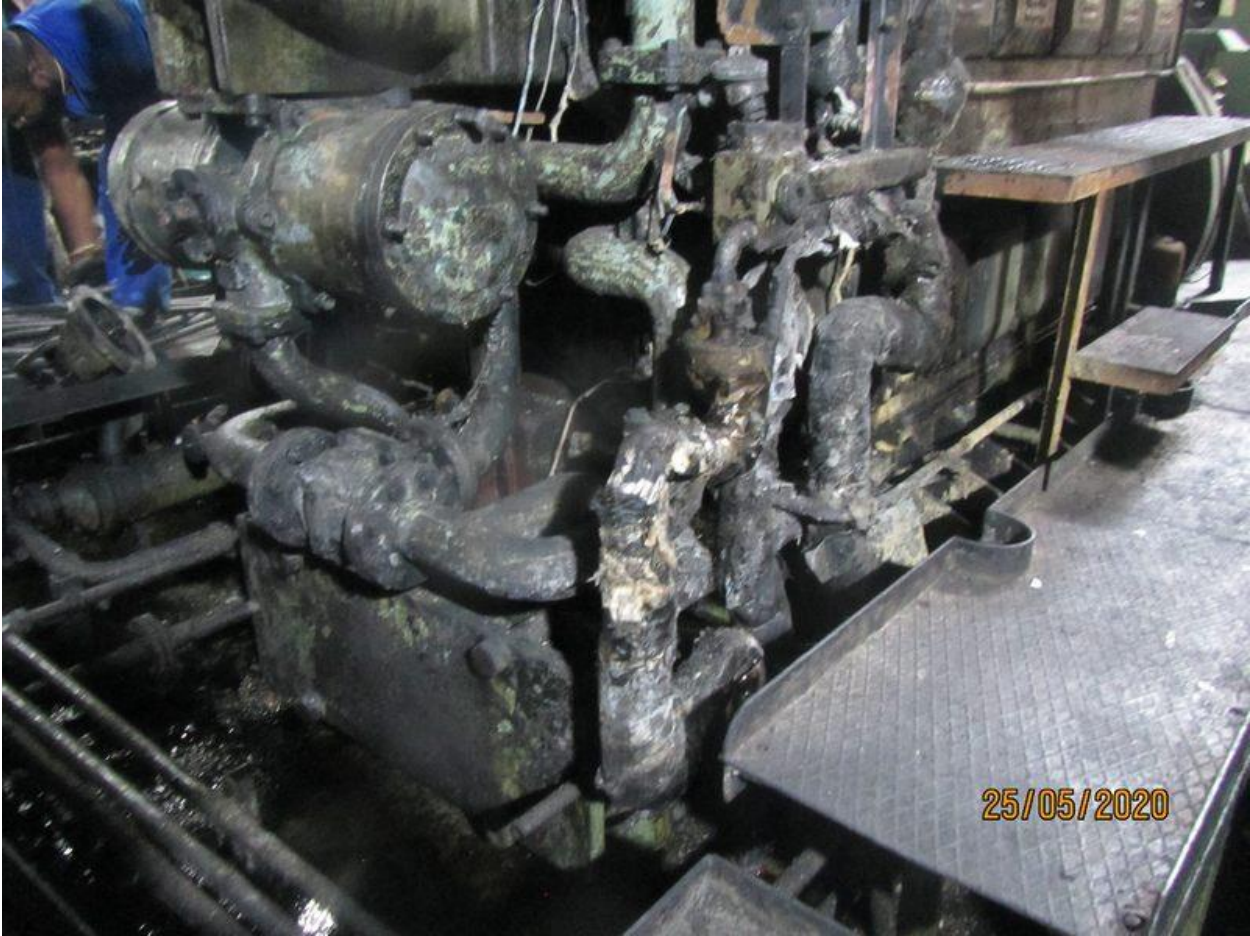
Consequences of the engine room fire which may have started when the fuel from the damaged filter casing sprayed over the engine exhaust manifold.
