Ref : DMA/AIFI/97/C 902

Inaccuracies in Draught Surveys

Loss Prevention Bulletin

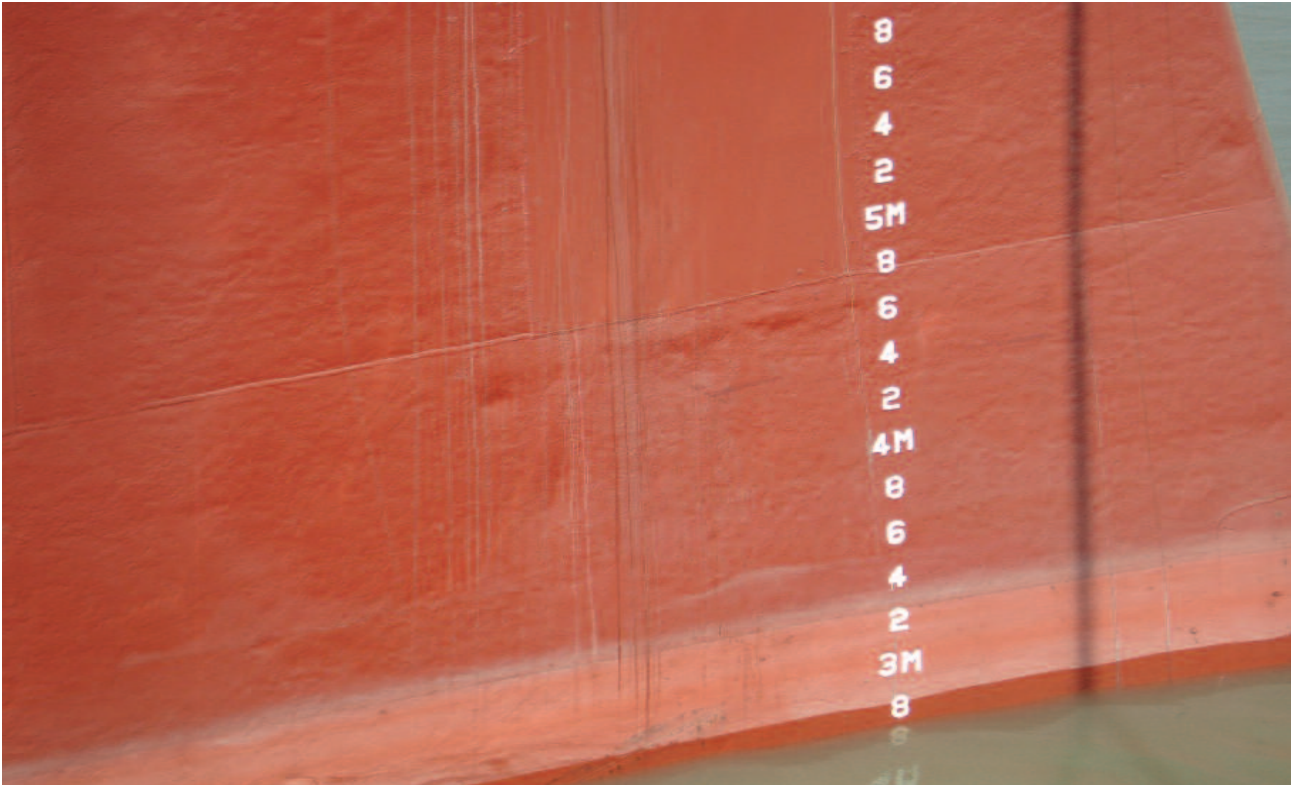
- Bilge water present in the cargo holds, machinery spaces, duct keel, void spaces and the chain lockers.
- Swimming pool water.
- Anchor and anchor cable on the seabed, either when at anchor or alongside and an anchor has been deployed as part of the mooring arrangement.
- Silt and mud can accumulate in the double bottom tanks of vessels regularly ballasting in rivers or estuaries. The extra

weight can give rise to an apparent increase in the cargo loaded.
